Site 162 Mill Pond

Great Marsh Coastal Wetlands Restoration Plan
Rapid Technical Assessment Site 162

Site 162: Mill Pond, Gloucester, MA

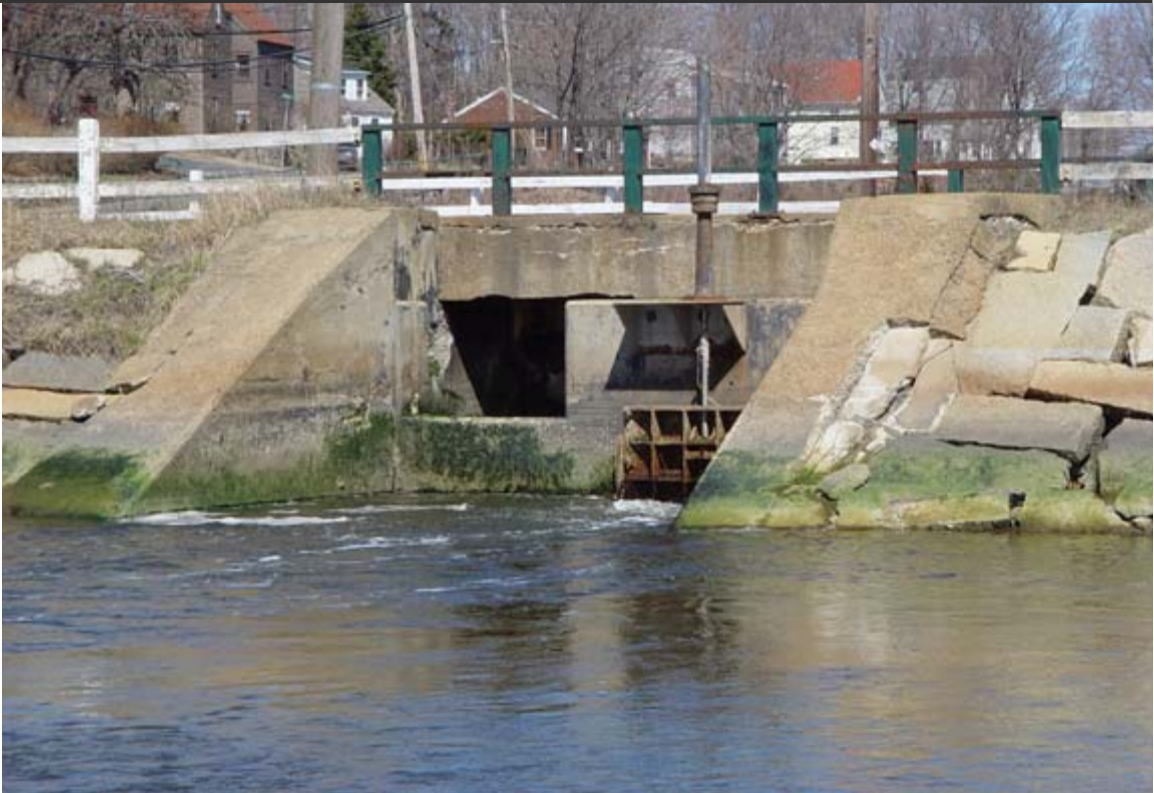
Photo 1 - Upstream View at Route 127 Crossing

The Route 127 Bridge is in fair condition based on those portions of the structure which could be visually inspected. Concrete on the bridge deck and abutments is spalling (spalling is when the concrete breaks away from the structure and is usually caused by rebar in the concrete corroding). Also the guardrail is deteriorating and the connections to the bridge have weakened due to corrosion and spalling of the concrete. The concrete associated with the flow control structure is in good condition.

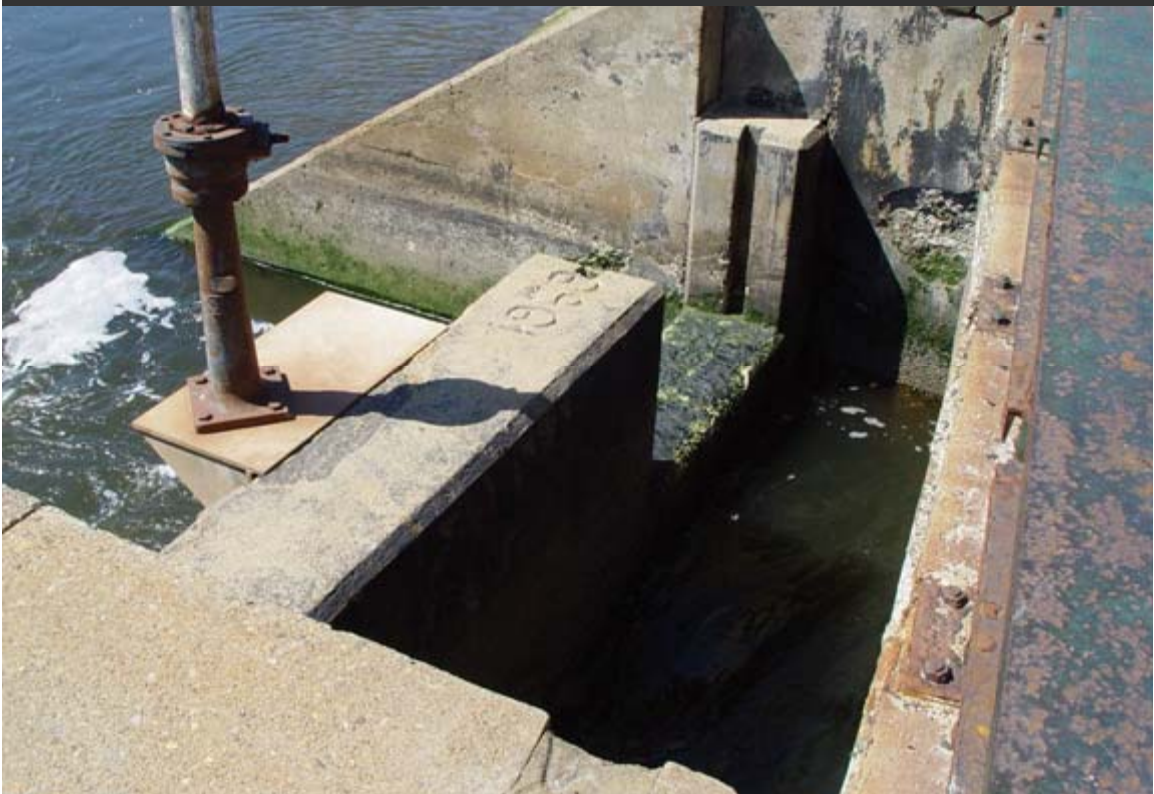
Photo 2 - Tide Gate

Structure Conditions: The Route 127 Bridge is a concrete deck on concrete abutments, with a span of approximately 15 ft. Water is conveyed under the bridge via a 14.5 ft wide by 11.5 ft high CMP Plate Arch culvert. In 1969, a concrete flow control structure was reconstructed between the upstream wing walls of the bridge. The previous flow structure was built in 1938, however its configuration is unknown. There were reportedly two larger culverts along Washington Street during the 1920's. There were no available records at the City Engineering Department indicating the age of the current Route 127 Bridge itself. Flow is currently regulated by a sluice gate with a 5 ft-wide by 3 ft-high opening. The sluice gate is operational but is currently maintained in an open position. The flow structure also includes a 5.5 ft- wide by 3.5 ft-high notch or spillway adjacent to the tide gate opening. The spillway base elevation is 2.6 ft NAVD and has notched sides to accommodate flash boards. No boards were in place at the time of inspection.

Enlarging of existing openings within the concrete wall of the flow control structure would be a relatively straight forward construction operation and would likely only require a limited shoulder closure. Dewatering needs would be minimal as the work could be scheduled around favorable tide conditions. The extensive overhead utilities would not be impacted. The work would likely be done with wet saws. The use of pneumatic hammers would not be recommended because of potential impacts to the adjacent abutments. A protective coating such as epoxy would then have to be applied to the exposed concrete to prevent corrosion. The size of the opening would be dependant on the structural stability of the existing concrete wall, impacts to upstream water levels, and ability to control (or shut down) the additional openings. A structural review of the flow control structure design plans suggests the existing weir can be cut to, or slightly below, the elevation invert of the sluice gate. This modification would more than double the exposing hydraulic opening during a mean spring tide event. A channel bracket designed to support flash boards could be fastened to the sides of the weir. This modification would avoid the costs associated with installation of a second gate. Construction costs associated with this concept are estimated to be \$70,000.

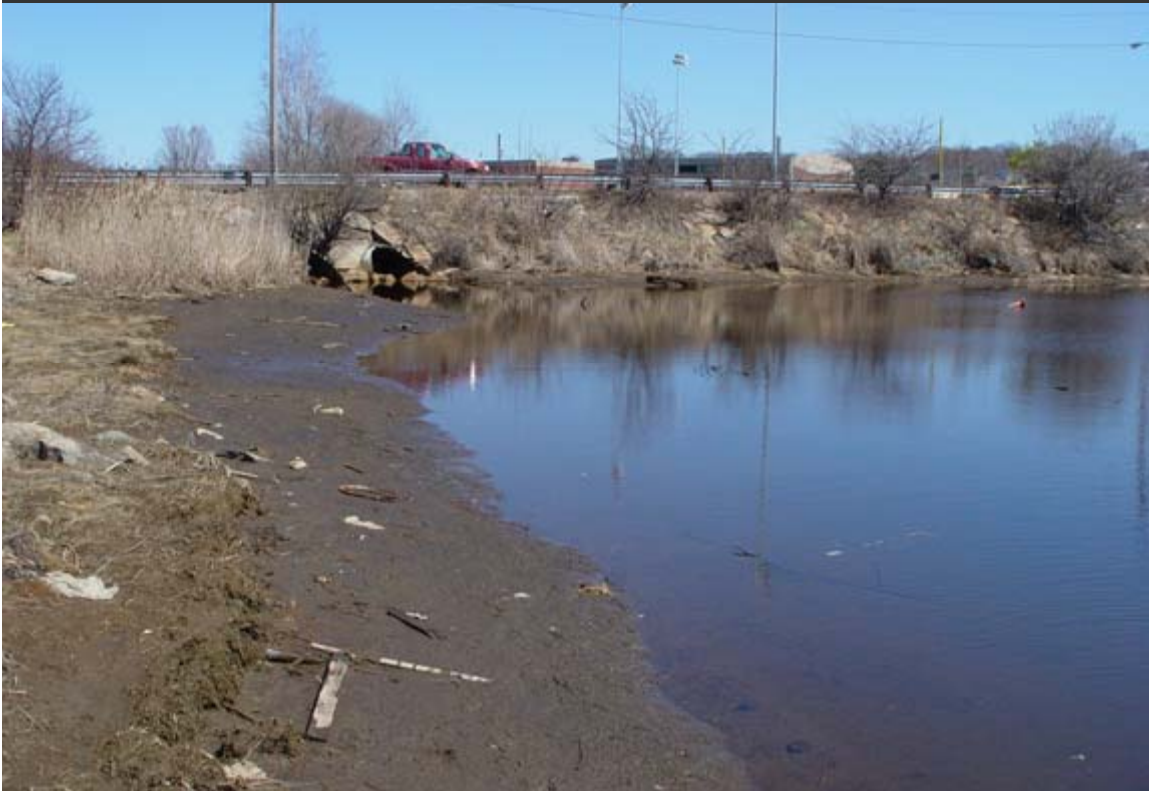
Photo 6 - Downstream View of Babson Road Crossing

The next upstream crossing of the tidal system occurs at Dr. Osman Babson Road. This road accesses the adjacent Middle School and is under the control of the School District. Water is conveyed under Dr. Osman Babson Road via twin 60 in CMP Plate culverts. The ends of the pipes have been beveled so as to follow the embankment slope. The upstream and downstream inverts have riprap scour protection. An excessive amount of riprap placed at the upstream end of the culverts results in a slight impounding condition. The embankment is also protected from erosion and scour by large placed riprap. Both pipes and the adjacent upstream and downstream embankments are in good condition.
